**Re: Ameren Missouri  
Sioux Power Station  
Response to Dewberry & Davis Draft Coal Combustion Waste Impoundments  
Round 7 – Dam Assessment Report**

RE: Ash Pond Dam Stability Analysis  
Sioux Power Station

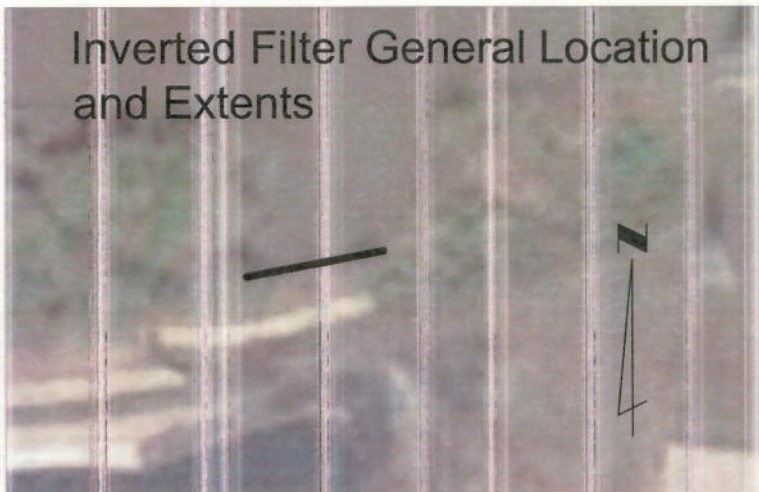
## Inverted Filter General Location and Extents

During the initial stages of this project RJ was made aware of a seepage area near the toe of the embankment close to the northeast corner of the bottom ash pond. The scope of this project was expanded to analyze and monitor the seepage, and provide recommendations for the remediation of this area. The seepage area consisted of one area with concentrated or “piping” type flow. In the same area, several “pin” type seeps were also observed flowing at the same time as the larger seep.

Observations of the seep show that the sediment yield is intermittent. The history of the seepage area is unknown. We recommend constructing an inverted filter over the bank of the seepage area to help stop the migration of fines from within the embankment. The details of the filter are presented in Appendix C. The filter should generally consist of a two foot thick base layer of coarse sand above the existing ground surface. The coarse sand should be overlain with a two foot intermediate layer consisting of gravel. Four feet of rip rap is recommended at the surface of the filter to protect against wave and current erosion. The recommended gradations for the coarse sand, and gravel and rip rap are presented in Appendix C. A sketch of the approximate location, limits of the filter and a typical cross-section of the filter are also presented in this appendix.

An inverted filter should be constructed over the downstream bank where seepage has been observed. The details of the inverted filter are provided in Appendix C. Monitoring of the seepage area should be continued. A densification program is recommended to remediate any potential voids caused by the transport of fines.

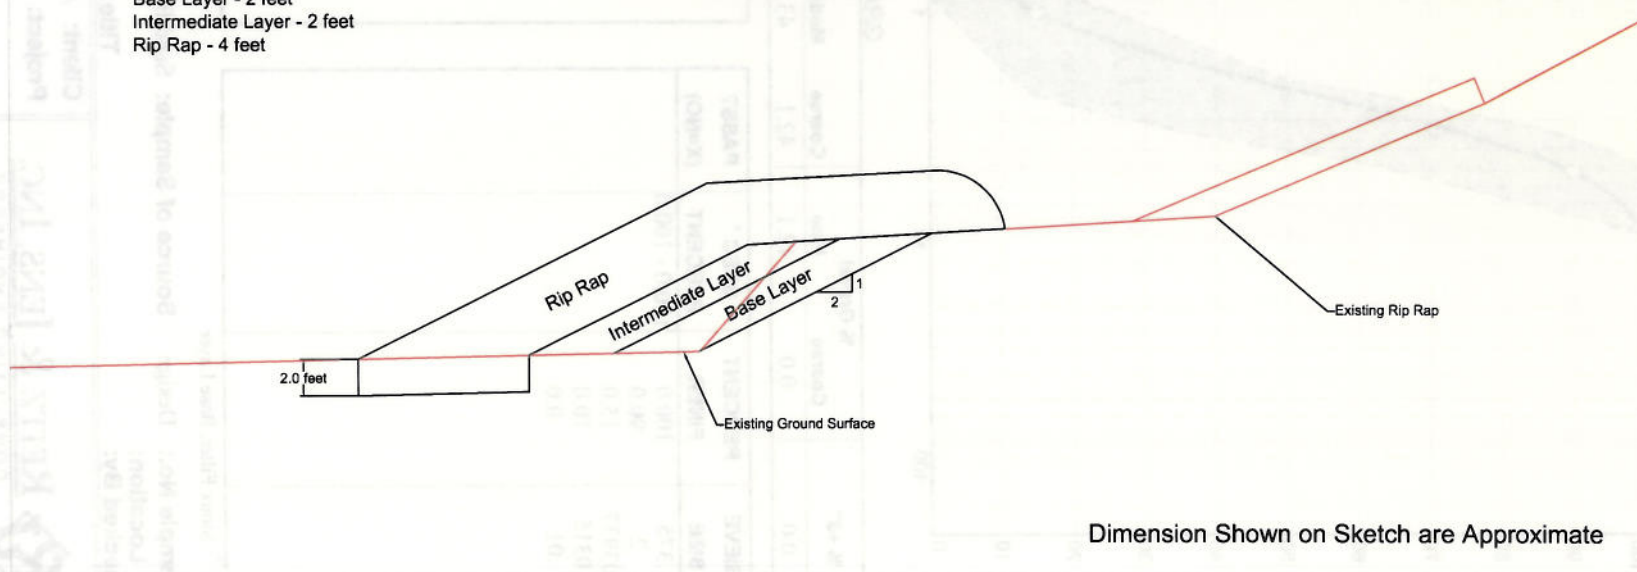
## Inverted Filter Cross-section

Layer Thickness  
Base Layer - 2 feet  
Intermediate Layer - 2 feet  
Rip Rap - 4 feet
